**CONDITION SURVEY AND ANALYSIS OF FIRST EPOXY ASPHALT
CONCRETE PAVEMENT ON ORTHOTROPIC BRIDGES IN CHINA
——A TEN-YEAR REVIEW**

Qing Lu, Assistant Professor

Sang Luo, Ph.D. (Corresponding author)

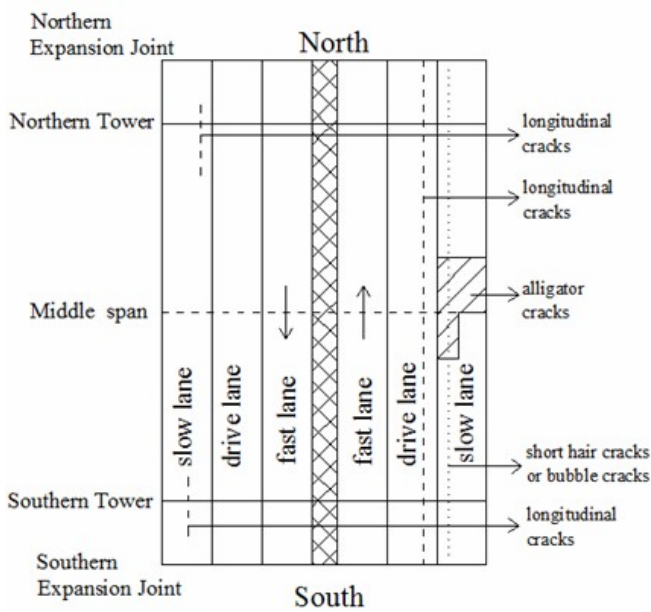
The windshield survey results are summarized in Fig. 2. As it can be seen, the bridge

pavement is in good condition in the two fast lanes, has some longitudinal regular cracks and short hair cracks in the northbound drive lane, and has potholes and irregular cracks including bubble cracks, ring cracks and alligator cracks in the two slow lanes. It is encouraging that no shoving or rutting distress was found on the entire epoxy asphalt pavement. Among all the pavement distresses, about 95 percent of them were observed on the two slow lanes, with 85 percent of the distresses occurring on the northbound slow lane, and 10 percent occurring on the southbound slow lane.

Fig. 2. Types and distribution of pavement distresses on NSYRB.

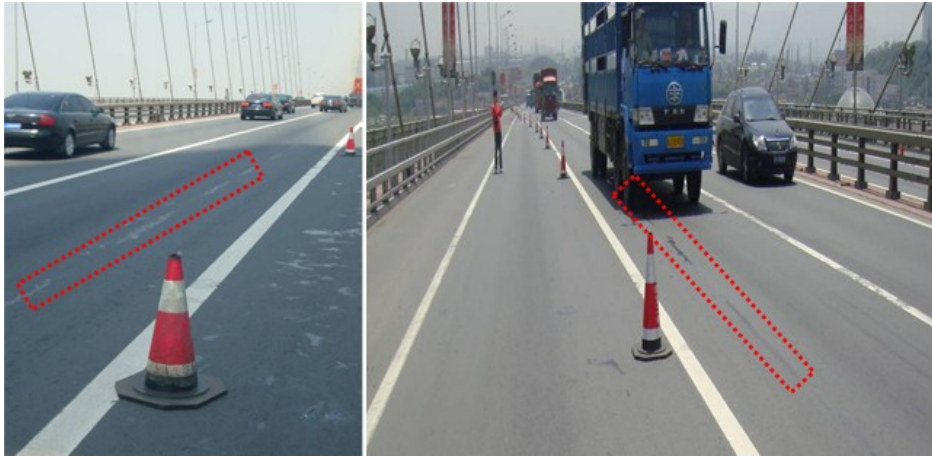
Regular crack is defined as a crack that is mostly caused by structural damage or thermal stress, and propagates longitudinally or transversely. Field investigation of NSYRB pavement shows that regular longitudinal cracks occurred along the positions of deck stiffening ribs or girders, or in the truck wheel paths. One longitudinal crack was found crossing the whole bridge in the northbound drive lane and located on top of the joint of one stiffening rib and the bridge deck, as shown in Fig. 3. In the southbound slow lane, two longitudinal cracks were also observed, one in the center of the lane, and the other in the right wheel path, as shown in Fig. 4.

Fig. 3. Longitudinal regular cracks in the northbound drive lane on NSYRB.

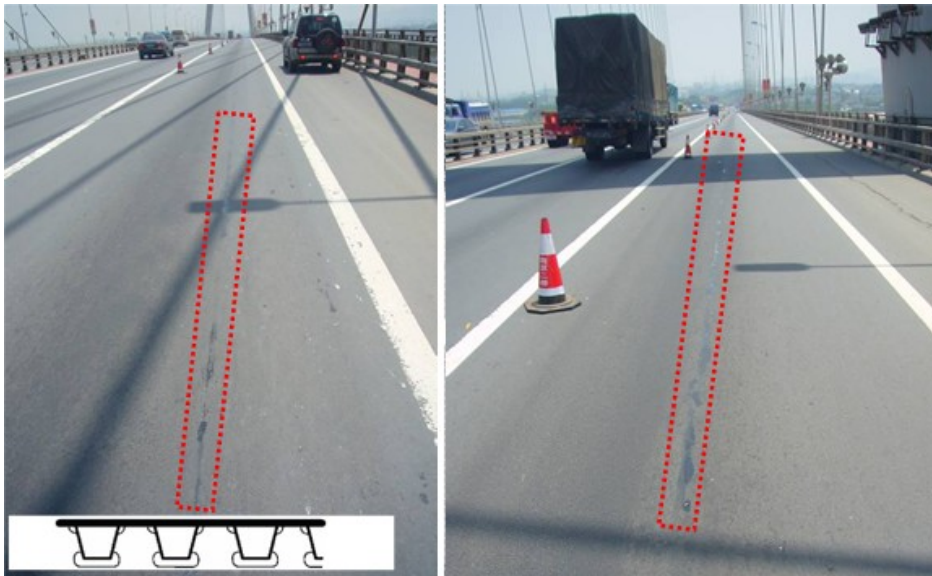
Regular cracks are mostly fatigue cracks caused by repeated traffic loading. To investigate the mechanism of initiation of regular cracks, a three dimensional (3D) finite element model of epoxy asphalt pavement on local orthotropic steel deck was established using the commercial software ADINA. An 8-node 3D solid element was selected to model the asphalt pavement and a shell element was used to model the steel bridge deck. Between the shell and solid elements, rigid links were adopted to make the pavement and steel deck deform together. A sensitivity analysis of stress response was then conducted to determine the FE mesh size. The mesh size was reduced gradually until difference between the stresses calculated with the new and the old mesh sizes was within 5 percent of the stresses calculated with the old mesh sizes (Xu et al. 2009). As a result, areas around the critical stress positions such as ribs were meshed with fine element sizes, while regions located far away from critical stress positions were meshed with coarse element sizes. The final FE model, as shown in Fig. 13(a), included 12756 elements. According to the survey results of tire pressure as shown in Table 1, a standard tire pressure of 0.7 MPa, a 60 percent overloading tire pressure 1.1 MPa, and a maximum tire pressure 1.38 MPa were selected for analysis. The calculated maximum strains in the pavement at various temperatures and tire pressures are shown in Fig. 13. The FEM simulation results show that the maximum pavement strain occurs at the pavement surface on top of a stiffener (rib) of the orthotropic deck, as represented by point A in Fig. 13(b).

Fig. 4. Longitudinal regular cracks in the southbound slow lane on NSYRB.

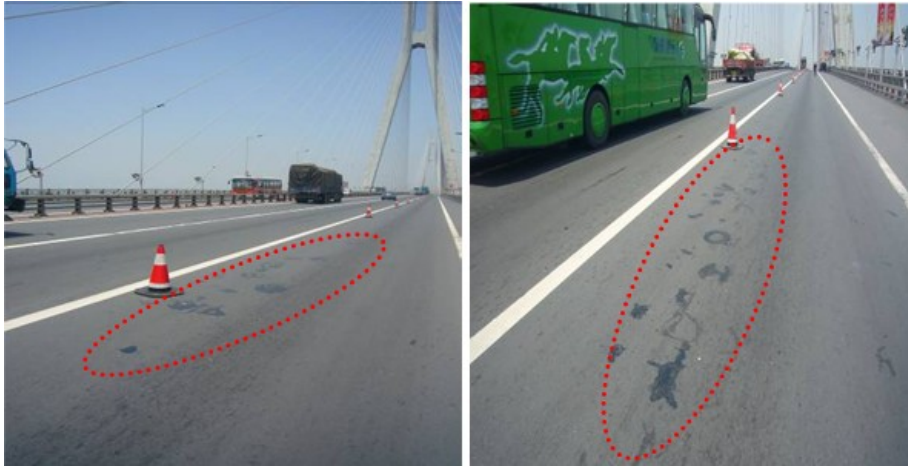
Short hair cracks are defined as cracks with irregular shapes, a length less than 30 cm, a width less than 0.2 cm, and a depth less than 2 cm, as illustrated in Fig. 5. Short hair cracks are

mostly observed at the surface of epoxy asphalt pavement on steel bridges. On-site survey on NSYRB revealed that pavement in the northbound slow lane had dozens of short hair cracks, most of which were located in the left wheel path from the southern expansion joint to southern tower.

Short hair cracks are typically caused by construction defects instead of deficiency in the pavement mixture or structural design. If short hair cracks are not sealed properly, they will develop into alligator cracks due to heavy traffic and environment influences. The relationship between initiation of short hair cracks and construction process needs further investigation to reduce the occurrence of this type of cracks.

Fig. 5. Short hair cracks in the northbound slow lane on NSYRB.

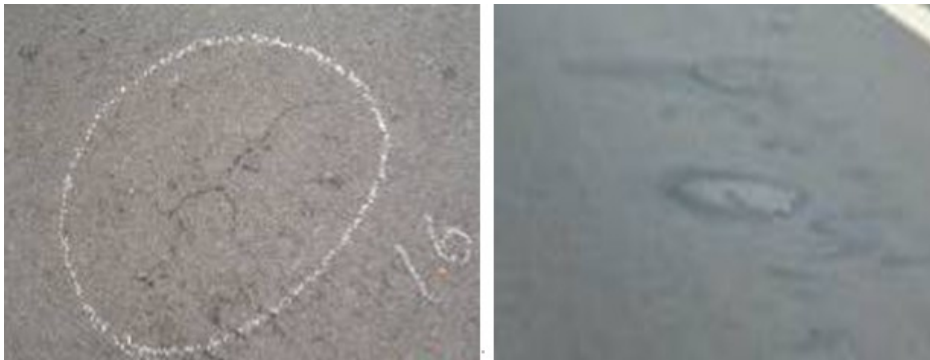
Bubble cracks are characterized with short radial cracks of about 15 cm lengths in at least three directions, as shown in Fig. 6(a). They are caused by moisture trapped underneath the pavement during construction. When deck temperature rises in the summer, the trapped moisture vaporizes and expands its volume, which heaves the impermeable pavement layer to form a pavement bubble. Under traffic loading, the bubble bursts, leaving bubble cracks on the pavement. Under further repeated traffic loading coupled with more ingress of water into the cracked area, ring cracks may appear around the radial cracks, as illustrated in Fig. 6(b). Based on the on-site investigation, both bubble and ring cracks were observed on NSYRB, and most of them were in both the northbound slow lane and the northbound drive lane.

Bubble cracks are caused by moisture introduced during the paving process. Sources of moisture include water dripping from bridge towers or cables, residual water on the deck after rain, and sweat from workers during paving. Such moisture contamination may exist on steel bridge decks paved with any type of asphalt mixture. However, it is interesting to observe that bubble cracks only occur in epoxy asphalt pavements, while they have not been observed on steel bridges paved with other asphalt mixtures, such as gussasphalt (with zero air-void content), polymer modified asphalt mixtures and stone mastic asphalt mixtures (with low air-void content). The reason is that epoxy asphalt mixture is mixed and placed at temperatures much lower than other asphalt mixtures so that epoxy resin can cure at a slow rate to ensure sufficient construction time. Typical mixing and compaction temperatures for epoxy asphalt are around 120°C and 110°C, respectively. Such temperatures cannot guarantee complete evaporation of moisture residuals on the steel deck before epoxy asphalt is placed and completely compacted. Therefore, moisture contamination should be strictly forbidden during the constructing process of epoxy asphalt pavement.

Ring cracks always appear around bubble cracks due to repeated traffic loading and/or potential dynamic water pressure. If the non-regular cracks are not timely treated, alligator

(a) Bubble crack

(b) Ring cracks

Fig. 6. Bubble and ring cracks in epoxy asphalt pavement on NSYRB.

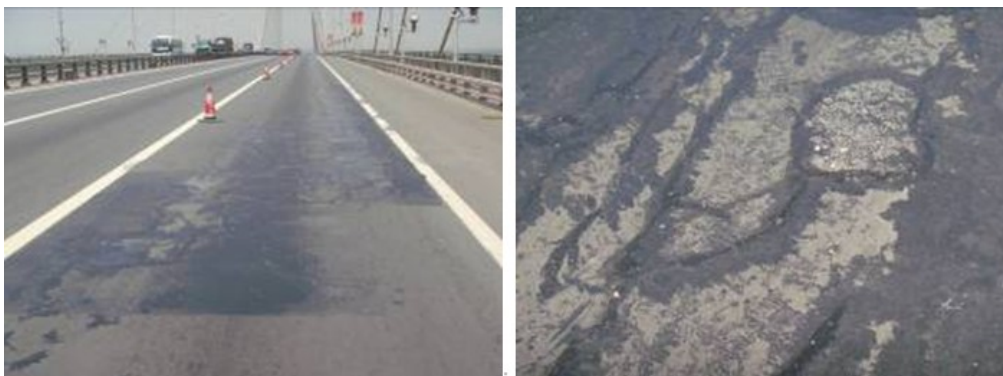
A few alligator cracks were found in the pavement on NSYRB. The most serious alligator cracking is in the northbound slow lane at the span center of the bridge, with a cracking area of about 20 m², as shown in Fig. 7.

Fig. 7. Alligator cracks in the northbound slow lane on NSYRB.

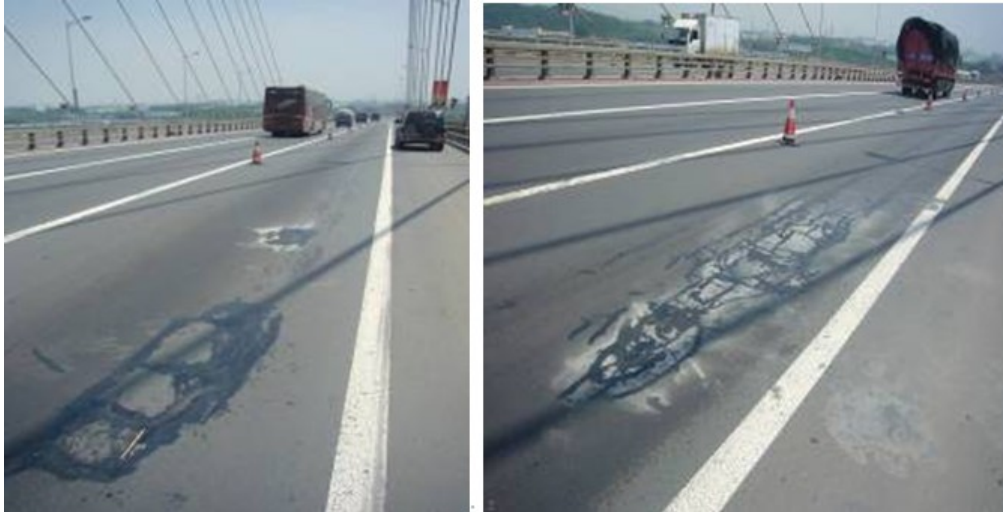
Another serious alligator crack occurred in the southbound slow lane at the span center between southern tower and southern expansion joint. As shown in Fig. 8, this alligator crack is also in the right wheel path.

Fig. 8. Alligator cracks in the southbound slow lane on NSYRB.

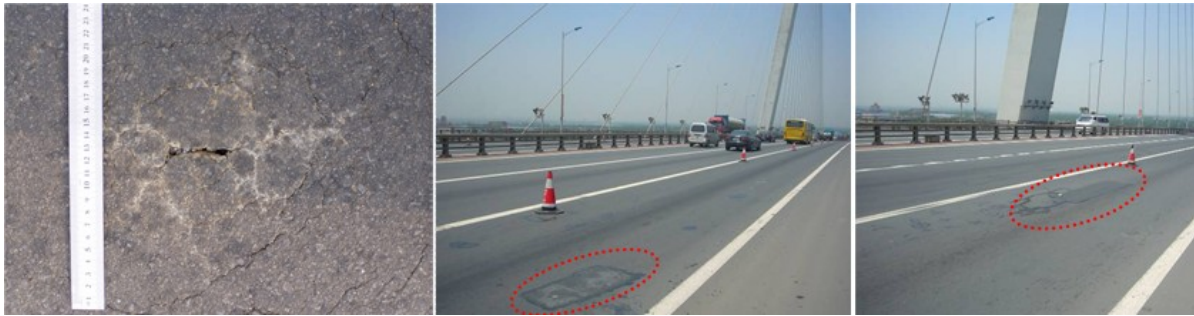
Potholes are developed from cracks under the coupling action of wheel loading and dynamic water pressure if the cracks are not sealed or patched in time. Long-term observation of epoxy asphalt pavement on NSYRB showed that a pothole first occurred in the pavement in the form as shown in Fig. 9(a). Two potholes were found in the pavement on the northbound slow lane, and had been patched by the maintenance crew of the bridge company. The distressed area is about 0.2 m² for one pothole, and about 2 m² for the other, as shown in Fig. 9(b) and Fig. 9(c), respectively. Moisture was trapped inside the potholes during the patching process, which later caused corrosion of the steel deck, as shown in Fig. 10.

If cracks are not sealed in time, water from rain or snow will infiltrate into the pavement. Under the coupling action of heavy truck loading and dynamic water pressure, potholes will eventually develop. To verify the detrimental effect of moisture on epoxy asphalt performance such as resistance to fatigue cracking, a strain-controlled four-point beam fatigue test was conducted on specimens conditioned with moisture. Such a test was designed to simulate the coupling effect of moisture and loading on the deterioration of epoxy asphalt pavement. The preconditioning procedure for moisture treatment was determined as follows: a specimen was first saturated in water at 635mm-Hg vacuum for 30 minutes and then placed in a 60°C water bath for 24 hours; After that, the specimen was cooled to 20°C and wrapped with Parafilm, a moisture-resistant, thermoplastic flexible plastic sheet, to retain its internal moisture. Moisture loss during the fatigue test can be controlled within one gram by Parafilm. Pictures of Parafilm and a beam wrapped with it are shown in Fig. 14.

(a) Small pothole

(b) Patched pavement for two potholes

Fig. 9. Pothole in epoxy asphalt pavement on NSYRB.

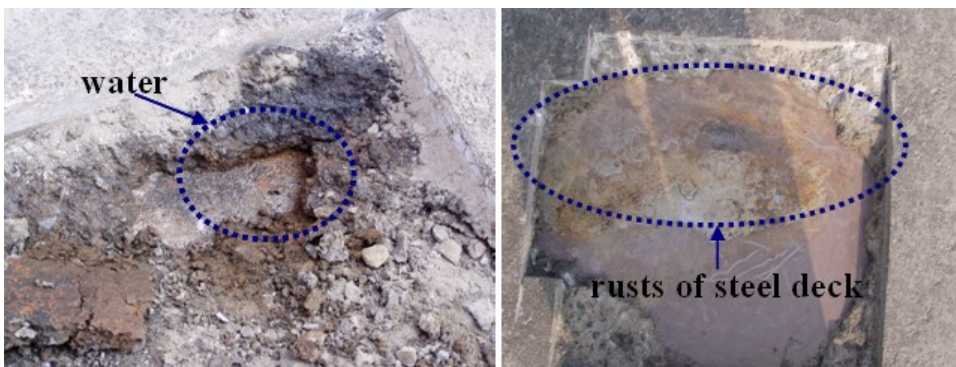
Fig. 10. Water remaining in the pavement and rust of the steel deck on NSYSB.

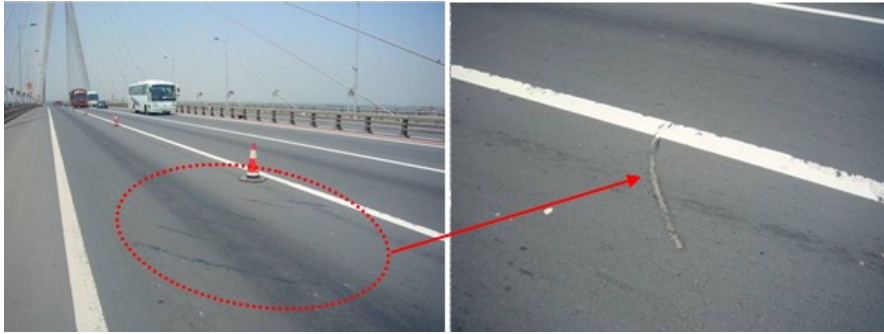
Other than the common pavement distresses discussed in the previous sections, accident distress was also found on the NSYRB pavement. A few scratches caused by the striking of

objects falling from vehicles were observed in the slow lanes, as shown in Fig. 11.

Fig. 11. Scratching on epoxy asphalt pavement on NSYRB.
